**Flood Control Project Maintenance
Levee Inspections**

Fall 2018 Levee Maintenance Deficiency Summary Report

San Joaquin River Basin

**Flood Control Project Maintenance
Levee Inspections****LMA District Cover Sheet****Fall 2018 Levee Inspection Results****Reclamation District No. 0524 Middle Roberts Island**

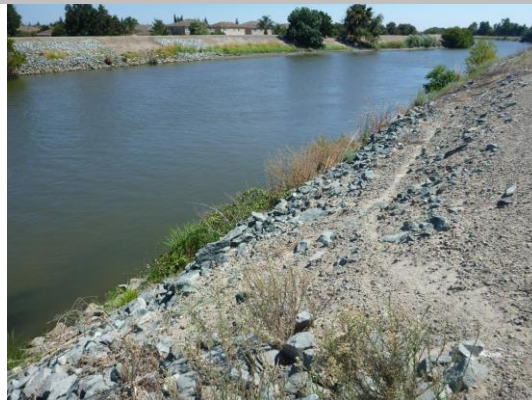
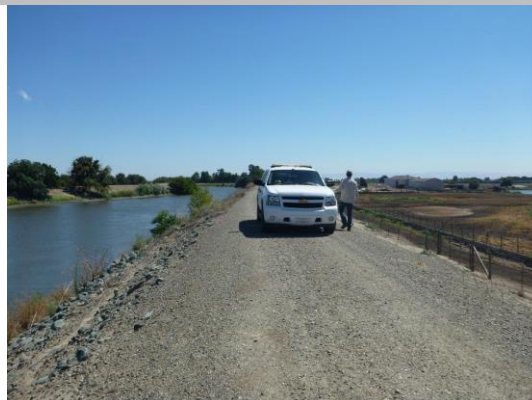
LM Start	2.96	Rating **	A/W	Issue No.	227
LM End		Issue Type +	Ma	Location *	
Category	Supplemental			GPS Latitude/Longitude	
				Start	End
Item	2017 Storm Damage			37.912900 °	°
				-121.324400 °	°
DWR ID	DWR_RD0524_01_f_2017_227

Description: Slope protection repairs are needed along the waterside slope due to erosion. Based upon levee inspections, it was determined the waterside levee slopes were eroding, deteriorating and degrading in concave pocket sections at various locations along this levee reach. The eroded levee sections need to be restored back to design standards to prevent further deterioration of the damaged levee sections.

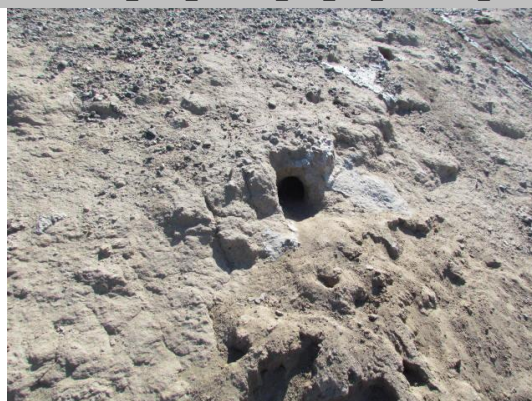
Photo 2 of 3 : FA_2018_RD0524_107_925_20180906_00365.jpg

Looking at typical view of rodent hole with this section fall 2015.

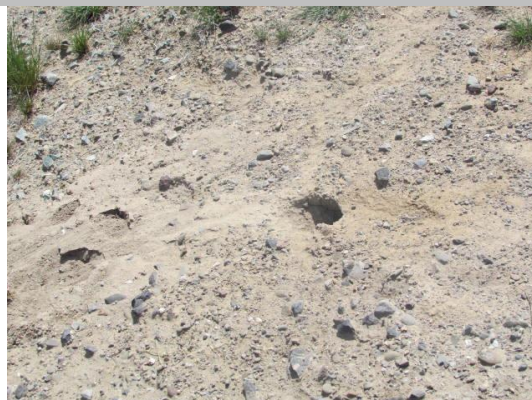
Photo 3 of 3 : FA_2018_RD0524_107_925_20180906_00366.jpg

Looking at typical rodent holes on landward slope along this reach.

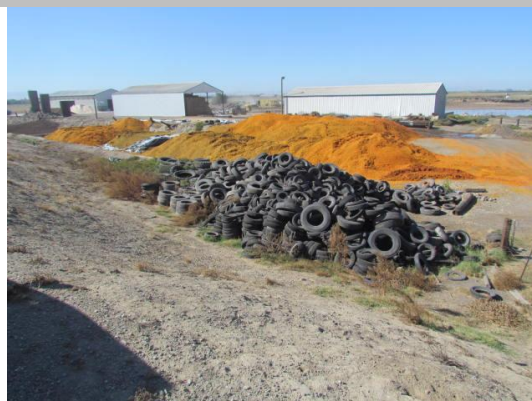
Photo 1 of 1 : FA_2018_RD0524_107_169_20180906_00220.jpg

LM Start	3.10	Rating **	U	Issue No.	169
LM End	3.10	Issue Type +	En	Location *	LS
Category	Earthen Levee			GPS Latitude/Longitude	
				Start	End
Item	Encroachments			37.911070 °	37.911070 °
				-121.325090 °	-121.325090 °
DWR ID	DWR_RD0524_01_f_2015_169				
Comment Code					
GA : Garbage					
Inspector Comment					
Rubber tire stockpile at landside toe.

Looking west at rubber tires at landward toe.

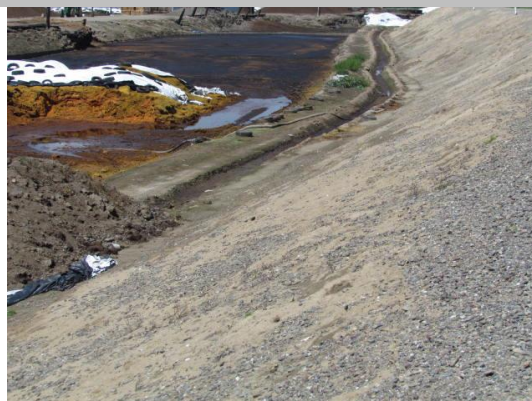
Photo 1 of 2 : FA_2018_RD0524_107_212_20180906_00278.jpg

LM Start	3.11	Rating **	M	Issue No.	212
LM End	3.27	Issue Type +	En	Location *	LS
Category	Earthen Levee			GPS Latitude/Longitude	
				Start	End
Item	Encroachments			37.910876 °	37.908558 °
				-121.325181 °	-121.325394 °
DWR ID	DWR_RD0524_01_s_2016_212				
Comment Code					
DT : Ditch					
Inspector Comment					
Shallow drainage ditch at landside toe.

Looking northwest at southend of ditch at landward toe.

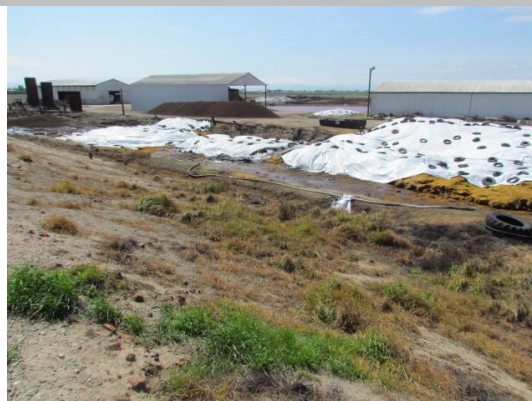
Photo 2 of 2 : FA_2018_RD0524_107_212_20180906_00279.jpg

Looking southwest at northend of ditch at landward toe.

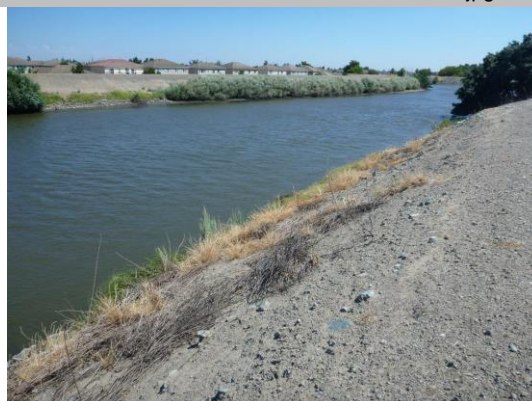
Photo 2 of 2 : LEVAL_FA_2018_466_2229.jpg

Item	2017 Storm Damage			37.909200 °	°					
				-121.325300 °	°					
DWR ID	DWR_RD0524_01_f_2017_229									
Comment Code										
Inspector Comment										
<p>Levee Evaluation Comments</p> <p>Description: Slope protection repairs are needed along the waterside slope due to erosion. Based upon levee inspections, it was determined the waterside levee slopes were eroding, deteriorating and degrading in concave pocket sections at various locations along this levee reach. The eroded levee sections need to be restored back to design standards to prevent further deterioration of the damaged levee sections.</p> <p>Site ID No: 466</p> <p>Site Designation: LMA-293</p> <p>Repair Type: Erosion</p> <p>Rating: Area of Concern</p> <p>Field Date: 7/26/2017</p> <p>Notes: Lower priority because damage is only on the lower 1/5 of slope. The slopes US and DS are rocky. Levee is narrow here.</p>

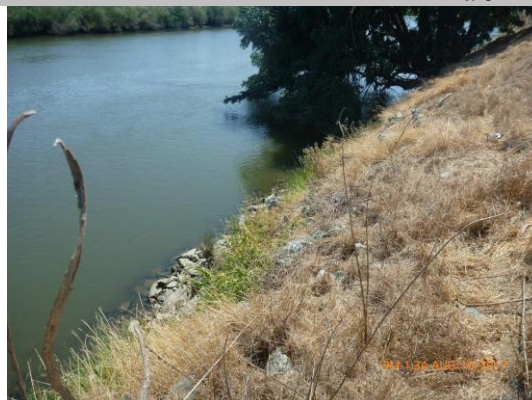
Photo 1 of 3 : LEVAL_FA_2018_528_4193.jpg

Item	2017 Storm Damage			37.908800 °	37.908700 °					
				-121.325400 °	-121.325300 °					
DWR ID	DWR_RD0524_01_f_2017_230									
Comment Code										
Inspector Comment										
<p>Levee Evaluation Comments</p> <p>Description: Slope protection repairs are needed along the waterside slope due to erosion and riprap displacement from high water. Based upon levee inspections, it was determined the waterside levee slope is eroding, deteriorating, and degrading. The eroded levee sections need to be restored back to design standards to prevent further deterioration and damage.</p> <p>Site ID No: 528</p> <p>Site Designation: LMA-434</p> <p>Repair Type: Erosion</p> <p>Rating: Area of Concern</p> <p>Field Date: 8/10/2017</p> <p>Notes: combined with LMA-433</p>

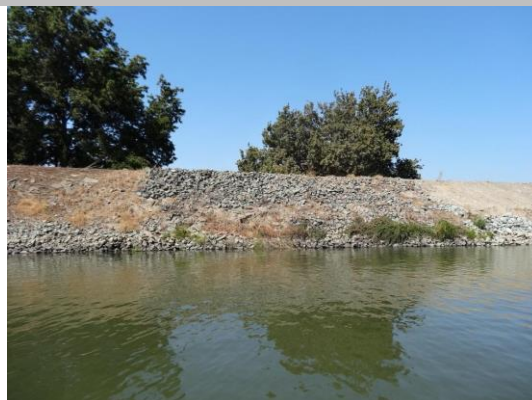
Photo 1 of 4 : FA_2018_RD0524_107_79_20180906_00136.jpg

LM Start	3.30	Rating **	U	Issue No.	79							
LM End	3.32	Issue Type +	Ma	Location *	WS							
Category	Supplemental		GPS Latitude/Longitude									
			Start	End								
Item	DWR Erosion Survey		37.908090 °	37.908090 °								
			-121.325090 °	-121.325090 °								
DWR ID	RD0524U01RM43.86											
Comment Code												
Inspector Comment												
<p>09/13/2017: No significant change observed.</p> <p>07/25/2016: No significant change observed.</p> <p>06/24/2015: No significant change observed.</p> <p>06/19/2014: No significant change observed.</p> <p>08/13/2013: The levee toe seems to have been protected by river rocks and vegetation on site. [2017 Site ID: RD0524U01RM43.86]</p>

Front View of the erosion.

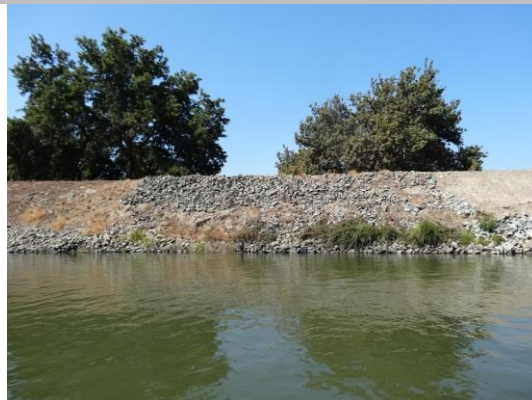
Photo 2 of 4 : FA_2018_RD0524_107_79_20180906_00137.jpg

Front view of the erosion.

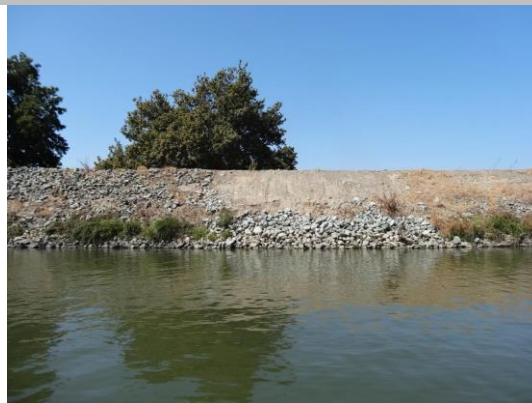
Photo 3 of 4 : FA_2018_RD0524_107_79_20180906_00138.jpg

Close view of the erosion. Note the river rocks and vegetation at the levee toe.

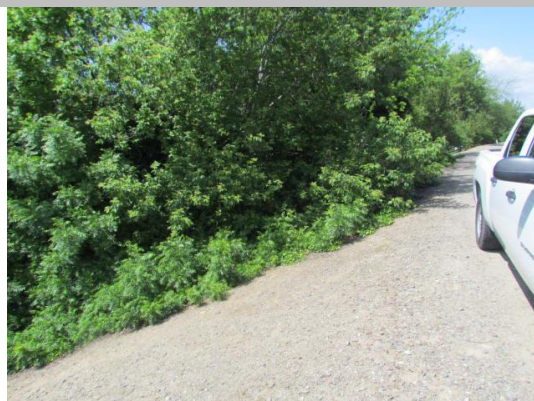
Photo 1 of 2 : FA_2018_RD0524_107_926_20180906_00367.jpg

LM Start	3.30	Rating **	U	Issue No.	926
LM End	3.37	Issue Type +	Ma	Location *	LS
Category	Earthen Levee			GPS Latitude/Longitude	
				Start	End
Item	Trim / Thin Trees			37.908158°	37.907112°
				-121.325418°	-121.325350°
DWR ID	DWR_RD0524_01_s_2012_926				
Comment Code					
T1 : Trim trees to at least five feet above ground level.					
Inspector Comment

Looking southwest at dense veg on landward slope.

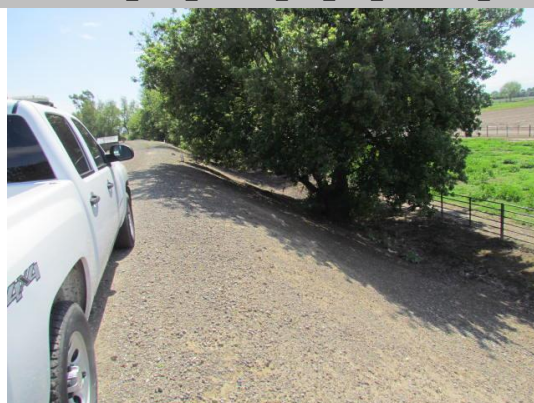
Photo 2 of 2 : FA_2018_RD0524_107_926_20180906_00368.jpg

Looking at untrimmed trees on landward slope and toe.

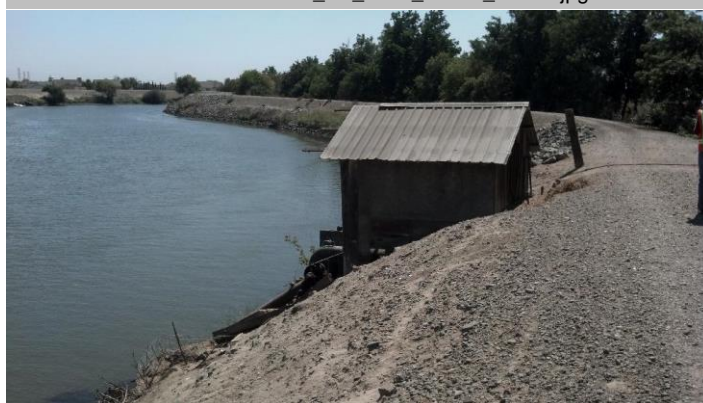
Photo 1 of 3 : UCIP_FA_2018_53357_30206.jpg

Comment Code					
Inspector Comment					
FS_ID:53357 DS_ID:20618 EP_NO: N/A Repair Type: Urgent Crossing Status: Found UCIP Comments: 10/2/2018 Same as previous inspection with severe LS slope integrity issues (D. Sanoski - DWR UCIP).11/16/2016 same as previous inspection erosion is still present on LS toe and slope. Owner will need to coordinate with CVFPB to address erosion issue on LS toe. (O. Magana - DWR UCIP)08/20/2013 Extensive erosion on LS toe at distribution box due to failure of box/pipe connection. Erosion on LS slope do to recently repaired leak at gate valve. (W. Wylie - DWR UCIP) FIELD_STRUCT_DESC: 14-inch steel irrigation pipe through the levee, 7 feet below the crown. Pump house located on the waterside (WS) slope. Gate valve located on the landside (LS) slope. 4-foot by 4-foot brick distribution box, built in 1918, located on the LS toe. This site was used to manufacture brick back in 1918, and some of the appurtenances that remain are still in use (distribution box and ditch). [Additional Reference(s): DWR Levee Log, 2004. USACE San Joaquin O&M Manual 7, April 1964, (HLM 3.38) 12-inch pipe listed, (conversation with owner, 2016)]. FS Date: 10/2/2018 1:42:00 PM

Pipe and pumphouse on WS slope.

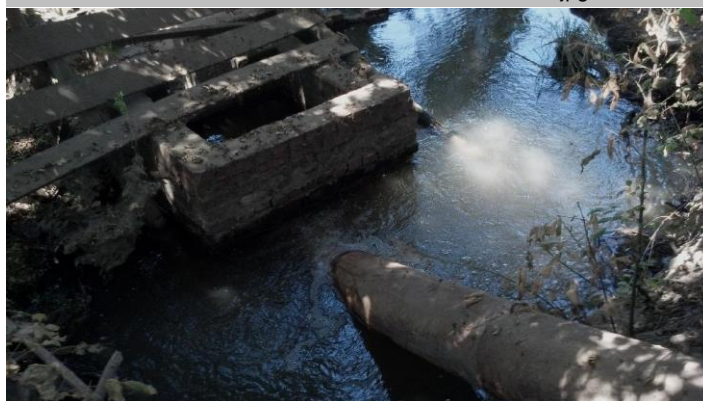
Photo 3 of 3 : UCIP_FA_2018_53357_30204.jpg

Comment Code						
Inspector Comment						
FS_ID:53357						
DS_ID:20618						
EP_NO: N/A						
Repair Type: Urgent						
Crossing Status: Found						
UCIP Comments: 10/2/2018 Same as previous inspection with severe LS slope integrity issues (D. Sanoski - DWR UCIP).11/16/2016 same as previous inspection erosion is still present on LS toe and slope. Owner will need to coordinate with CVFPB to address erosion issue on LS toe. (O. Magana - DWR UCIP)08/20/2013 Extensive erosion on LS toe at distribution box due to failure of box/pipe connection. Erosion on LS slope do to recently repaired leak at gate valve. (W. Wylie - DWR UCIP)						
FIELD_STRUCT_DESC: 14-inch steel irrigation pipe through the levee, 7 feet below the crown. Pump house located on the waterside (WS) slope. Gate valve located on the landside (LS) slope. 4-foot by 4-foot brick distribution box, built in 1918, located on the LS toe. This site was used to manufacture brick back in 1918, and some of the appurtenances that remain are still in use (distribution box and ditch). [Additional Reference(s): DWR Levee Log, 2004. USACE San Joaquin O&M Manual 7, April 1964, (HLM 3.38) 12-inch pipe listed, (conversation with owner, 2016)].

Extensive erosion around distribution box at LS toe.

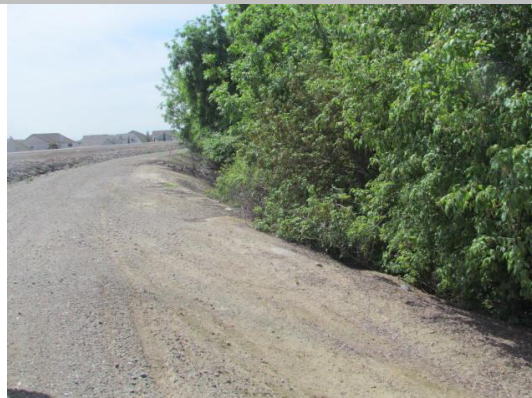
Photo 1 of 1 : FA_2018_RD0524_107_57_20180906_00101.jpg

LM Start	3.51	Rating **	U	Issue No.	57
LM End	3.59	Issue Type +	Ma	Location *	LS
Category	Earthen Levee			GPS Latitude/Longitude	
				Start	End
Item	Trim / Thin Trees			37.905638 °	37.904570 °
				-121.323892 °	-121.324215 °
DWR ID	DWR_RD0524_01_s _ 2012_57				
Comment Code					
T3 : Trim and thin trees to allow visibility of the ground and room to flood fight.					
Inspector Comment

Looking south at dense trees on landward slope.

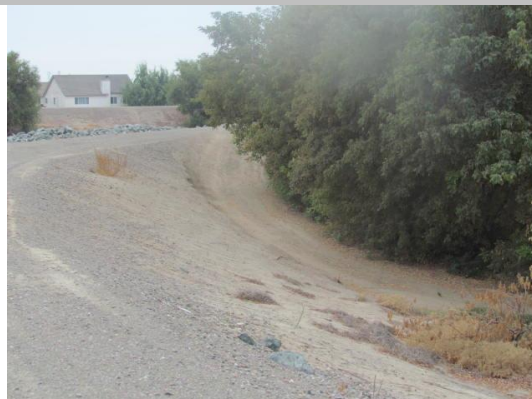
Photo 1 of 1 : FA_2018_RD0524_107_265_20180906_00354.jpg

LM Start	3.51	Rating **	M	Issue No.	265
LM End	3.51	Issue Type +	En	Location *	LS
Category	Earthen Levee			GPS Latitude/Longitude	
				Start	End
Item	Encroachments			37.905552 °	37.905552 °
				-121.323847 °	-121.323847 °
DWR ID	DWR_RD0524_01_s _ 2012_265				
Comment Code					
RA : Ramp					
Inspector Comment					
Unauthorized ramp on landside slope.

Looking southeast at unauthorized ramp on landside slope and toe.

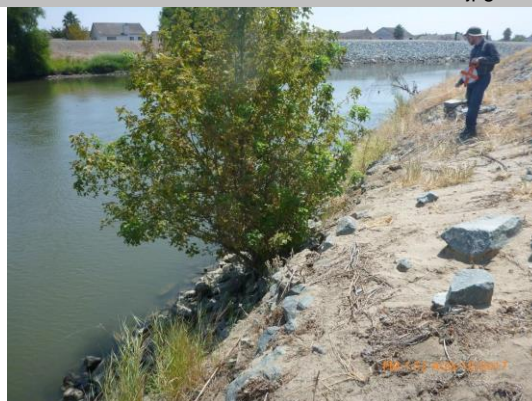
Photo 1 of 3 : LEVAL_FA_2018_526_4201.jpg

LM Start	3.53	Rating **	A/W	Issue No.	233
LM End	3.54	Issue Type +	Ma	Location *	
Category	Supplemental			GPS Latitude/Longitude	
				Start	End
Item	2017 Storm Damage			37.905300 °	37.905200 °
				-121.323800 °	-121.323900 °
DWR ID	DWR_RD0524_01_f_2017_233				
Comment Code					
Inspector Comment					
Levee Evaluation Comments					
Description:Slope protection repairs are needed along the waterside slope due to erosion and riprap displacement from high water. Based upon levee inspections, it was determined the waterside levee slope is eroding, deteriorating, and degrading. The eroded levee sections need to be restored back to design standards to prevent further deterioration and damage.					
Site ID No:526					
Site Designation:LMA-432					
Repair Type: Erosion					
Rating:Area of Concern					
Field Date:8/10/2017					
Notes:

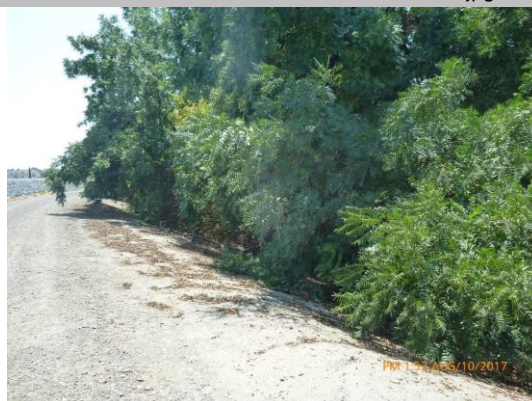
Photo 3 of 3 : LEVAL_FA_2018_526_4203.jpg

Item	2017 Storm Damage		37.905300°	37.905200°						
			-121.323800°	-121.323900°						
DWR ID	DWR_RD0524_01_f_2017_233									
Comment Code										
Inspector Comment										
<p>Levee Evaluation Comments</p> <p>Description: Slope protection repairs are needed along the waterside slope due to erosion and riprap displacement from high water. Based upon levee inspections, it was determined the waterside levee slope is eroding, deteriorating, and degrading. The eroded levee sections need to be restored back to design standards to prevent further deterioration and damage.</p> <p>Site ID No: 526</p> <p>Site Designation: LMA-432</p> <p>Repair Type: Erosion</p> <p>Rating: Area of Concern</p> <p>Field Date: 8/10/2017</p> <p>Notes:</p>

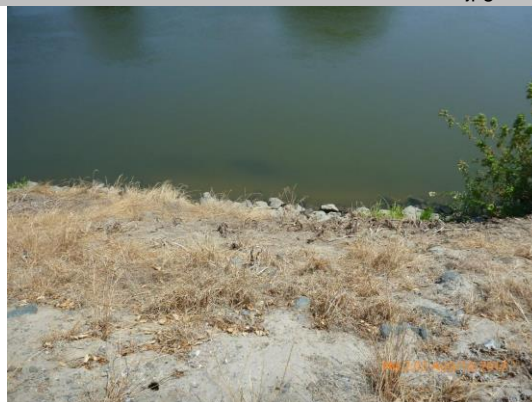
Photo 1 of 3 : LEVAL_FA_2018_525_4205.jpg

Item	2017 Storm Damage		37.904900°	37.904800°						
			-121.323900°	-121.324100°						
DWR ID	DWR_RD0524_01_f_2017_234									
Comment Code										
Inspector Comment										
<p>Levee Evaluation Comments</p> <p>Description: Slope protection repairs are needed along the waterside slope due to erosion and riprap displacement from high water. Based upon levee inspections, it was determined the waterside levee slope is eroding, deteriorating, and degrading. The eroded levee sections need to be restored back to design standards to prevent further deterioration and damage.</p> <p>Site ID No: 525</p> <p>Site Designation: LMA-431</p> <p>Repair Type: Erosion</p> <p>Rating: Area of Concern</p> <p>Field Date: 8/10/2017</p> <p>Notes:</p>

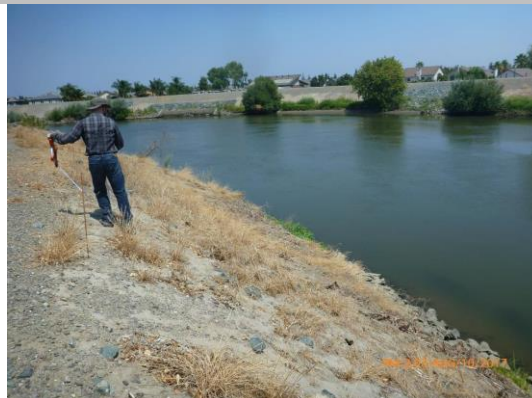
Photo 2 of 3 : LEVAL_FA_2018_525_4206.jpg

LM Start	3.56	Rating **	A/W	Issue No.	234 (cont)	
LM End	3.57	Issue Type +	Ma	Location *		
Category	Supplemental			GPS Latitude/Longitude		
				Start	End	
Item	2017 Storm Damage			37.904900 °	37.904800 °	
				-121.323900 °	-121.324100 °	
DWR ID	DWR_RD0524_01_f_2017_234					
Comment Code						
Inspector Comment						
Levee Evaluation Comments						
Description:Slope protection repairs are needed along the waterside slope due to erosion and riprap displacement from high water. Based upon levee inspections, it was determined the waterside levee slope is eroding, deteriorating, and degrading. The eroded levee sections need to be restored back to design standards to prevent further deterioration and damage.						
Site ID No:525						
Site Designation:LMA-431						
Repair Type: Erosion						
Rating:Area of Concern						
Field Date:8/10/2017						
Notes:

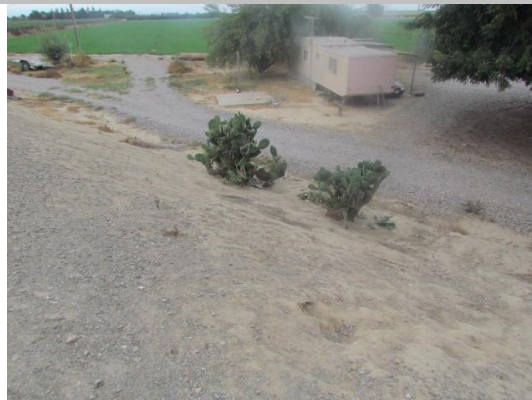
Photo 1 of 1 : FA_2018_RD0524_107_124_20180906_00188.jpg

LM Start	3.61	Rating **	M	Issue No.	124
LM End	3.61	Issue Type +	En	Location *	LS
Category	Earthen Levee			GPS Latitude/Longitude	
				Start	End
Item	Vegetation			37.904375 °	37.904375 °
				-121.324615 °	-121.324615 °
DWR ID	DWR_RD0524_01_f_2012_124				
Comment Code					
V6 : Landscaping					
Inspector Comment					
Landowner planted cactus on landside toe.

Looking west at cactus on landside toe.

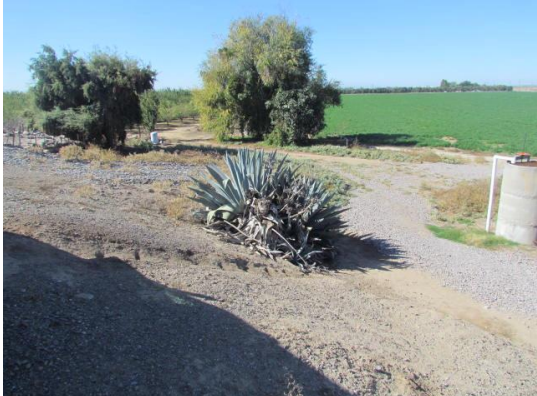
Photo 1 of 1 : FA_2018_RD0524_107_190_20180906_00250.jpg

Looking southwest at century plant at landward toe fall 2015.

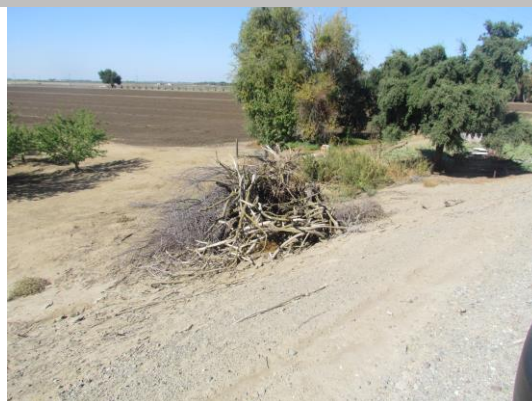
Photo 1 of 1 : FA_2018_RD0524_107_192_20180906_00251.jpg

LM Start	3.67	Rating **	A/W	Issue No.	192
LM End	3.67	Issue Type +	En	Location *	LS
Category	Earthen Levee			GPS Latitude/Longitude	
				Start	End
Item	Encroachments			37.903782 °	37.903782 °
				-121.325363 °	-121.325363 °
DWR ID	DWR_RD0524_01_s_2015_192				
Comment Code					
PR : Prunings					
Inspector Comment					
Large pruning piles at landside toe.

Looking west at pruning pile at landward toe.

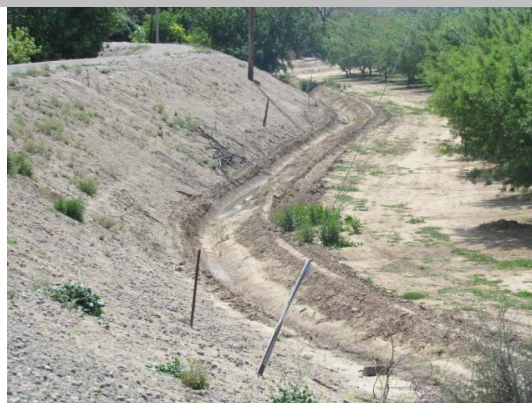
Photo 1 of 2 : FA_2018_RD0524_107_194_20180906_00255.jpg

LM Start	3.69	Rating **	U	Issue No.	194
LM End	3.78	Issue Type +	En	Location *	LS
Category	Earthen Levee			GPS Latitude/Longitude	
				Start	End
Item	Encroachments			37.903553 °	37.902505 °
				-121.325468 °	-121.326425 °
DWR ID	DWR_RD0524_01_s_2015_194				
Comment Code					
DT : Ditch					
Inspector Comment					
Shallow Irrigation ditch at landside toe.

Looking south at irrigation ditch at landward toe.

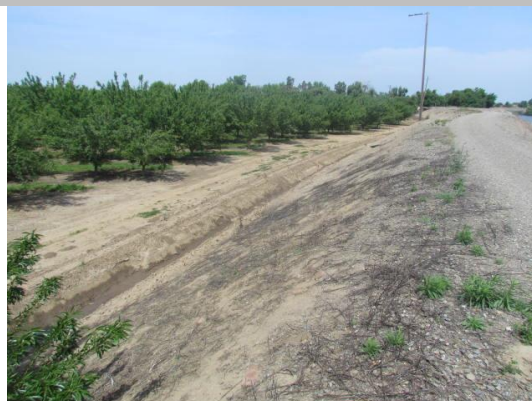
Photo 2 of 2 : FA_2018_RD0524_107_194_20180906_00256.jpg

Looking east at south end of irrigation ditch at landward toe.

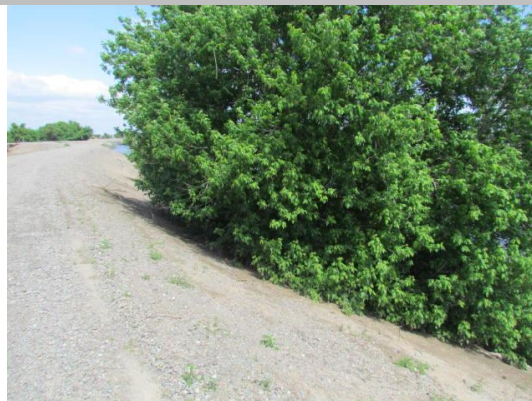
Photo 1 of 1 : FA_2018_RD0524_107_52_20180906_00094.jpg

LM Start	3.75	Rating **	U	Issue No.	52
LM End	3.75	Issue Type +	Ma	Location *	WS
Category	Earthen Levee			GPS Latitude/Longitude	
				Start	End
Item	Trim / Thin Trees			37.902828 °	37.902828 °
				-121.326170 °	-121.326170 °
DWR ID	DWR_RD0524_01_s_2016_52				
Comment Code					
T1 : Trim trees to at least five feet above ground level.					
Inspector Comment

Looking south at untrimmed tree on landward slope and toe.

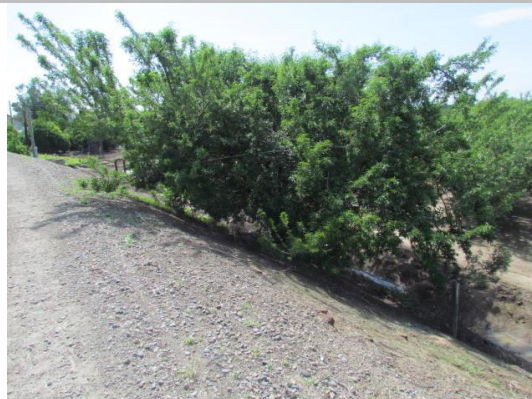
Photo 1 of 1 : FA_2018_RD0524_107_927_20180906_00369.jpg

LM Start	3.77	Rating **	U	Issue No.	927
LM End	3.77	Issue Type +	Ma	Location *	LS
Category	Earthen Levee			GPS Latitude/Longitude	
				Start	End
Item	Trim / Thin Trees			37.902645 °	37.902645 °
				-121.326340 °	-121.326340 °
DWR ID	DWR_RD0524_01_s_2012_927				
Comment Code					
T1 : Trim trees to at least five feet above ground level.					
Inspector Comment					
Untrimmed almond tree on landside slope.

Looking southwest at untrimmed tree at landward toe.

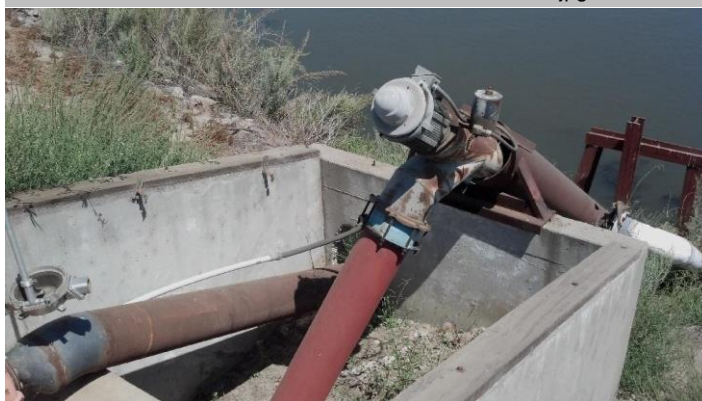
Photo 2 of 3 : UCIP_FA_2018_18307_30527.jpg

Comment Code						
Inspector Comment						
FS_ID:18307 DS_ID:20620 EP_NO: N/A Repair Type: Non-Urgent Crossing Status: Found UCIP Comments: Appears abandoned and if so should be done so properly. Evidence of severe internal corrosion in concrete distribution box at LS toe. FIELD_STRUCT_DESC: 12-inch concrete encased steel irrigation pipe through the levee, 10.5 feet below the crown. Pump and gate valve in pump house on the waterside (WS) slope. 6-foot by 6-foot Concrete distribution box on the landside (LS) toe. Two concrete cutoff walls. Service pole at the LS toe. [Additional Reference(s): DWR Levee Log, 2004. USACE San Joaquin O&M Manual 7, April 1964, (HLM 3.83)]. FS Date: 8/20/2013

Slant pump and pipe on WS slope.

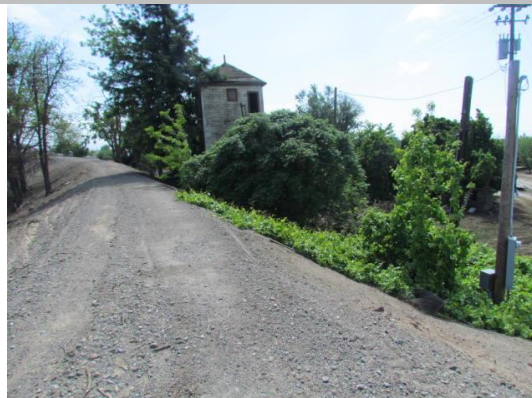
Photo 1 of 2 : FA_2018_RD0524_107_59_20180906_00104.jpg

LM Start	3.79	Rating **	U	Issue No.	59
LM End	3.80	Issue Type +	En	Location *	LS
Category	Earthen Levee			GPS Latitude/Longitude	
				Start	End
Item	Vegetation			37.902287°	37.902163°
				-121.326462°	-121.326476°
DWR ID	DWR_RD0524_01_s_2012_59				
Comment Code					
V6 : Landscaping					
Inspector Comment					
Downed tree on landward slope.

Looking south at dense veg on landward slope and toe.

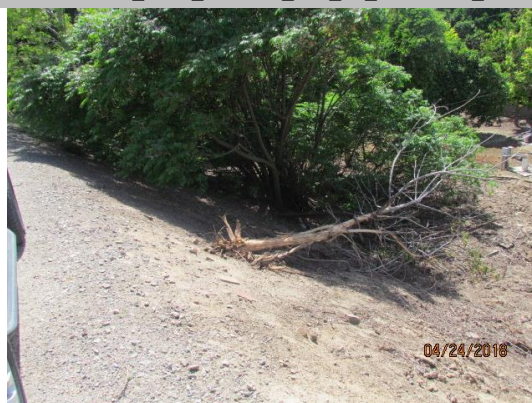
Photo 2 of 2 : FA_2018_RD0524_107_59_20180906_00105.jpg

Looking at fallen tree on landward slope. (Spring 2018)

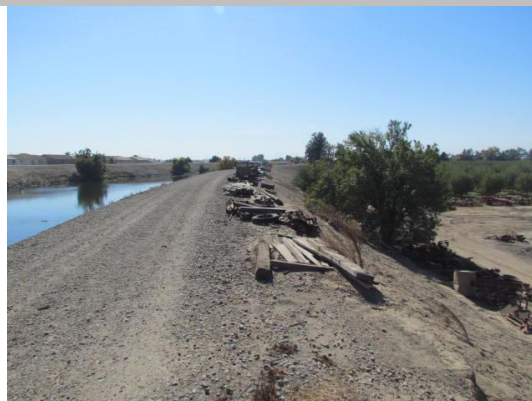
Photo 1 of 3 : FA_2018_RD0524_107_95_20180906_00161.jpg

LM Start	3.87	Rating **	U	Issue No.	95
LM End	3.97	Issue Type +	En	Location *	LS
Category	Earthen Levee			GPS Latitude/Longitude	
				Start	End
Item	Encroachments			37.901147 °	37.899764 °
				-121.326453 °	-121.326589 °
DWR ID	DWR_RD0524_01_f_2013_95				
Comment Code					
EQ : Equipment					
Inspector Comment					
Landowner is storing equipment on landside shoulder and landside toe.

Looking south at farm equipment stored on landward shoulder and toe.

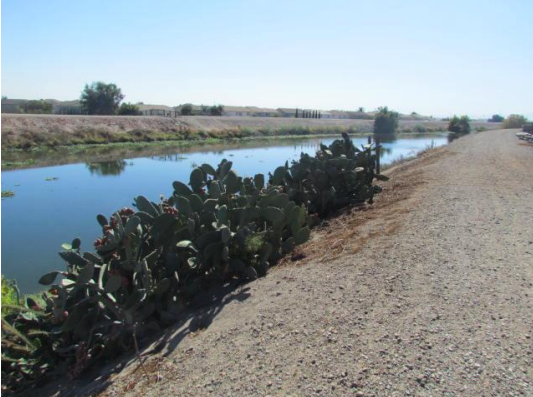
Photo 1 of 2 : FA_2018_RD0524_107_94_20180906_00159.jpg

Looking southeast at cactus on waterward slope fall 2015

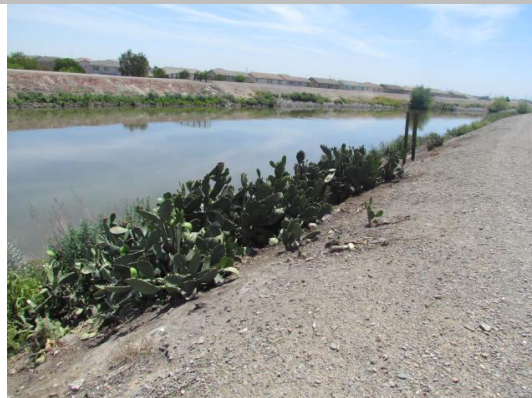
Photo 2 of 2 : FA_2018_RD0524_107_94_20180906_00160.jpg

LM Start	3.89	Rating **	U	Issue No.	94 (cont)	
LM End	3.89	Issue Type +	Ma	Location *	WS	
Category	Earthen Levee			GPS Latitude/Longitude		
				Start		End
Item	Vegetation			37.900940 °		37.900940 °
				-121.326414 °		-121.326414 °
DWR ID	DWR_RD0524_01_s_2012_94					
Comment Code						
V2 : Remove the wild growth other than native grasses from the levee slopes.						
Inspector Comment						
Remove cactus from waterside slope.

Looking southeast at cactus on waterside slope. Fall 2013

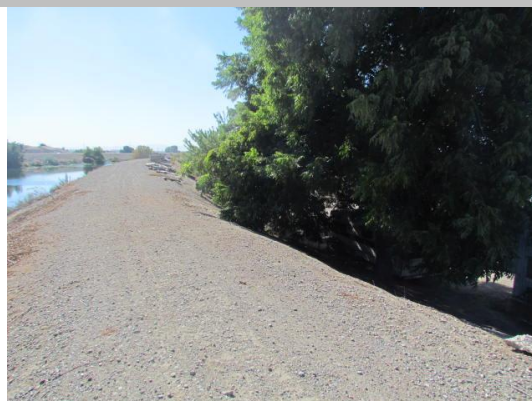
Photo 1 of 1 : FA_2018_RD0524_107_83_20180906_00147.jpg

LM Start	3.89	Rating **	U	Issue No.	83
LM End	3.90	Issue Type +	En	Location *	LS
Category	Earthen Levee			GPS Latitude/Longitude	
				Start	End
Item	Encroachments			37.900915 °	37.900760 °
				-121.326414 °	-121.326414 °
DWR ID	DWR_RD0524_01_f_2017_83				
Comment Code					
TR : Tree or limb					
Inspector Comment					
Untrimmed trees on landside slope.

Looking south at untrimmed trees on landward slope and toe.

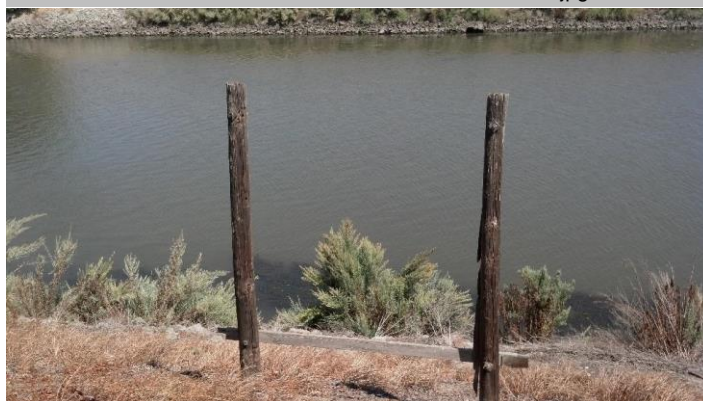
Photo 1 of 2 : UCIP_FA_2018_41464_30543.jpg

FS_ID:41464
DS_ID:20621
EP_NO: N/A
Repair Type: Non-Urgent
Crossing Status: Found
UCIP Comments: Appears to be abandoned as signage has been removed.
FIELD_STRUCT_DESC: 2.5-inch submarine telephone conduit of an unknown material through the levee and across the channel, 2 feet below the crown. Sign posts remain on both sides of the river on the waterside (WS) slope. [Additional Reference(s): DWR Levee Log, 2004].
FS Date: 8/20/2013

Sign posts with sign removed on WS slope.

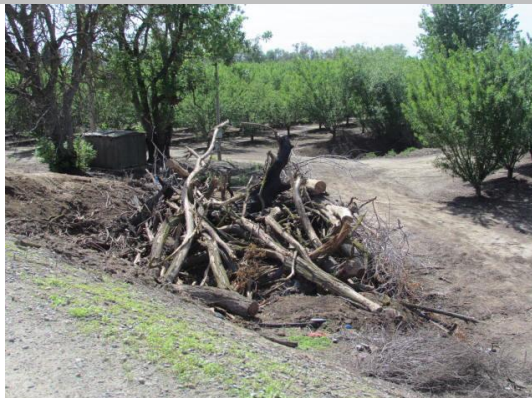
Photo 2 of 2 : FA_2018_RD0524_107_195_20180906_00258.jpg

LM Start	4.02	Rating **	U	Issue No.	195 (cont)	
LM End	4.02	Issue Type +	En	Location *	LS	
Category	Earthen Levee			GPS Latitude/Longitude		
				Start		End
Item	Encroachments			37.899093 °	37.899093 °	
				-121.326933 °	-121.326933 °	
DWR ID	DWR_RD0524_01_s_2015_195					
Comment Code						
PR : Prunings						
Inspector Comment						
Pruning pile blocking view of landside slope.

Looking at pruning pile at landward toe. (Spring 2016)

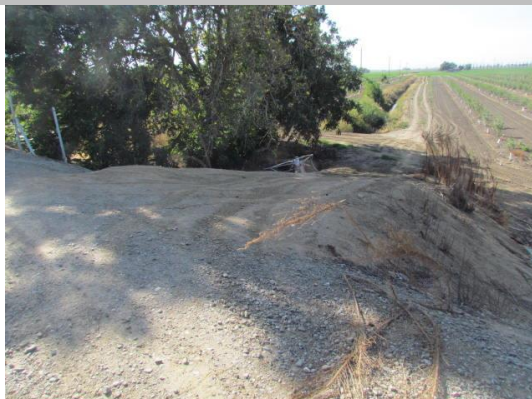
Photo 1 of 1 : FA_2018_RD0524_107_101_20180906_00165.jpg

LM Start	4.02	Rating **	U	Issue No.	101
LM End	4.02	Issue Type +	En	Location *	LS
Category	Earthen Levee			GPS Latitude/Longitude	
				Start	End
Item	Encroachments			37.899027 °	37.899027 °
				-121.326982 °	-121.326982 °
DWR ID	DWR_RD0524_01_s_2012_101				
Comment Code					
RA : Ramp					
Inspector Comment					
Unauthorized ramp. Ramp does not meet Title 23 standard.

Looking west at unauthorized ramp on landside slope.

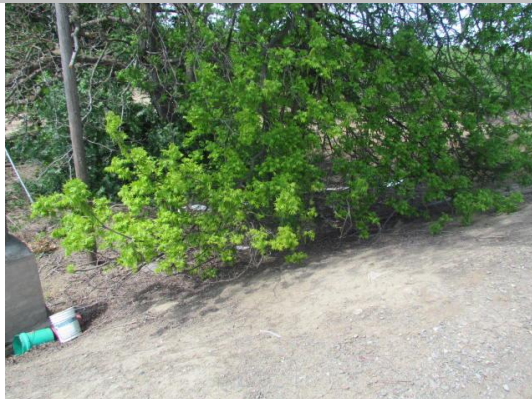
Photo 1 of 1 : FA_2018_RD0524_107_61_20180906_00110.jpg

LM Start	4.03	Rating **	M	Issue No.	61
LM End	4.03	Issue Type +	Ma	Location *	LS
Category	Earthen Levee			GPS Latitude/Longitude	
				Start	End
Item	Trim / Thin Trees			37.898925 °	37.898925 °
				-121.327015 °	-121.327015 °
DWR ID	DWR_RD0524_01_s_2012_61				
Comment Code					
T1 : Trim trees to at least five feet above ground level.					
Inspector Comment

Looking east at untrimmed tree at landward toe.

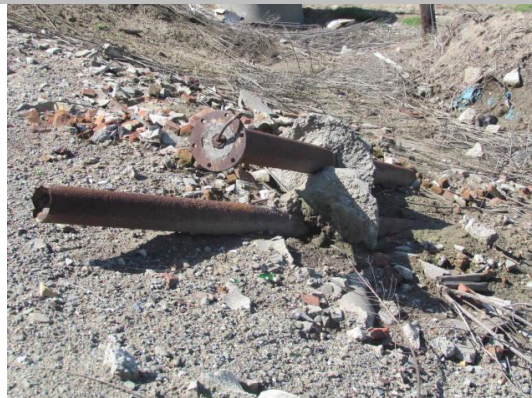
Photo 1 of 1 : FA_2018_RD0524_107_213_20180906_00280.jpg

LM Start	4.16	Rating **	M	Issue No.	213
LM End	4.16	Issue Type +	Ma	Location *	LS
Category	Earthen Levee			GPS Latitude/Longitude	
				Start	End
Item	Encroachments			37.897235 °	37.897235 °
				-121.327865 °	-121.327865 °
DWR ID	DWR_RD0524_01_s_2016_213				
Comment Code					
GA : Garbage					
Inspector Comment					
Old fence post and concrete and brick rubble on landside slope.

Looking west at old fence post and concrete rubble on landward slope.

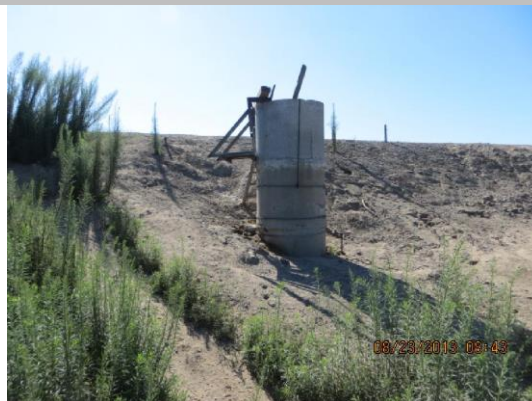
Photo 1 of 3 : UCIP_FA_2018_18318_30589.jpg

LM Start	4.16	Rating **	M	Issue No.	957
LM End	4.16	Issue Type +	En	Location *	
Category	Supplemental			GPS Latitude/Longitude	
				Start	End
Item	DWR UCIP Field Study			37.897118 °	37.897118 °
				-121.327910 °	-121.327910 °
DWR ID	20625				
Comment Code					
Inspector Comment					
FS_ID:18318 DS_ID:20625 EP_NO: N/A Repair Type: Non-Urgent Crossing Status: Found UCIP Comments: Small leak on WS slope causing minor erosion on WS slope. FIELD_STRUCT_DESC: 12-inch steel irrigation pipe through the levee, 4.5 feet below the crown. Pump house and gate valve on the waterside (WS) slope. 36-inch concrete standpipe, power pole, and meter on the landside (LS) toe. [Additional Reference(s): DWR Levee Log, 2004. USACE San Joaquin O&M Manual 7, April 1964, (HLM 4.21)]. FS Date: 8/23/2013

Concrete standpipe on LS slope.

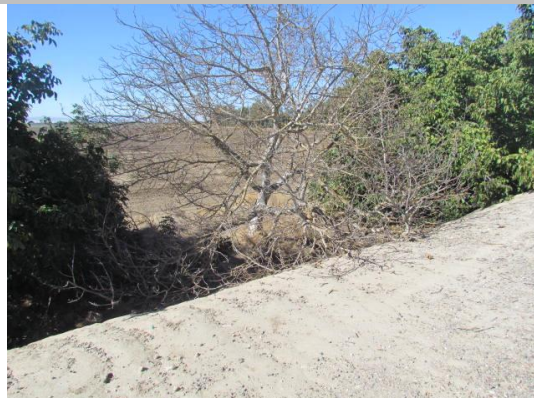
Photo 1 of 1 : FA_2018_RD0524_107_199_20180906_00264.jpg

LM Start	4.42	Rating **	M	Issue No.	199
LM End	4.42	Issue Type +	Ma	Location *	LS
Category	Earthen Levee			GPS Latitude/Longitude	
				Start	End
Item	Encroachments			37.893659 °	37.893659 °
				-121.329092 °	-121.329092 °
DWR ID	DWR_RD0524_01_f_2015_199				
Comment Code					
TR : Tree or limb					
Inspector Comment					
Remove dead tree from landside toe.

Looking west at dead tree on landward slope and toe fall 2015.

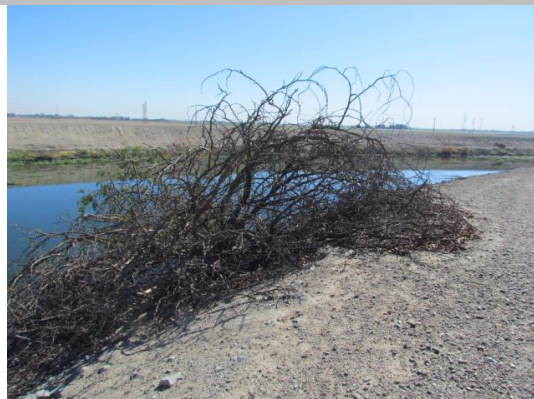
Photo 1 of 2 : FA_2018_RD0524_107_102_20180906_00166.jpg

LM Start	4.52	Rating **	U	Issue No.	102
LM End	4.52	Issue Type +	Ma	Location *	WS
Category	Earthen Levee			GPS Latitude/Longitude	
				Start	End
Item	Encroachments			37.892383 °	37.892383 °
				-121.328194 °	-121.328194 °
DWR ID	DWR_RD0524_01_f_2016_102				
Comment Code					
TR : Tree or limb					
Inspector Comment					
Dead tree on waterside slope.

Looking southeast at dead tree on waterside slope fall 2015

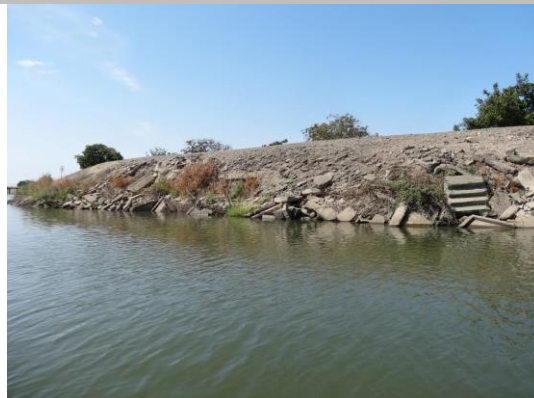
Photo 1 of 3 : FA_2018_RD0524_107_90_20180906_00152.jpg

LM Start	4.53	Rating **	A/W	Issue No.	90
LM End	4.54	Issue Type +	Ma	Location *	WS
Category	Supplemental			GPS Latitude/Longitude	
				Start	End
Item	DWR Erosion Survey			37.892230 °	37.892230 °
				-121.327930 °	-121.327930 °
DWR ID	RD0524U01RM45.07				
Comment Code					
Inspector Comment					
09/13/2017: No significant change observed.					
07/25/2016: No significant change observed.					
06/24/2015: No significant change observed.					
06/19/2014: No significant change observed.					
08/13/2013: No significant change observed.					
08/07/2012: The erosion is located at the inside of a river bend. Site is covered with broken concrete blocks and other debris. [2017 Site ID:RD0524U01RM45.07]

Front view of the erosion site.

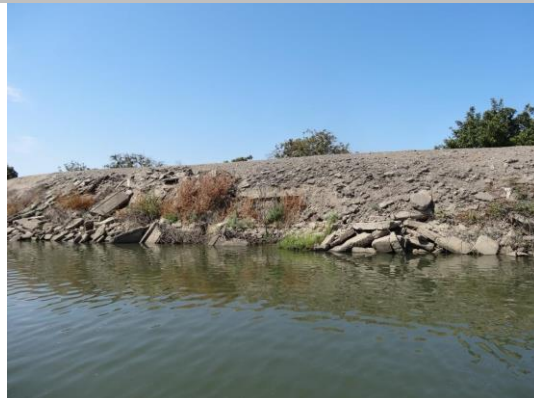
Photo 2 of 3 : FA_2018_RD0524_107_90_20180906_00153.jpg

Close view of the site.

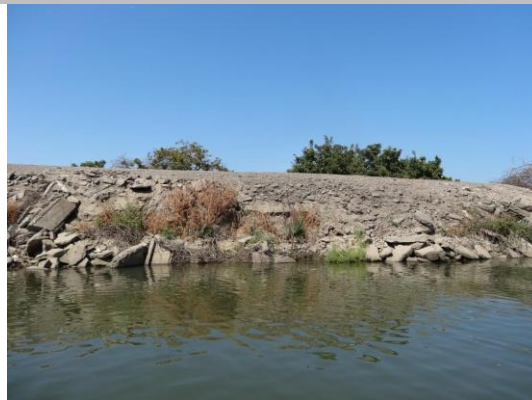
Photo 3 of 3 : FA_2018_RD0524_107_90_20180906_00154.jpg

LM Start	4.53	Rating **	A/W	Issue No.	90 (cont)
LM End	4.54	Issue Type +	Ma	Location *	WS
Category	Supplemental			GPS Latitude/Longitude	
				Start	End
Item	DWR Erosion Survey			37.892230 °	37.892230 °
				-121.327930 °	-121.327930 °
DWR ID	RD0524U01RM45.07				
Comment Code					
Inspector Comment					
09/13/2017: No significant change observed.					
07/25/2016: No significant change observed.					
06/24/2015: No significant change observed.					
06/19/2014: No significant change observed.					
08/13/2013: No significant change observed.					
08/07/2012: The erosion is located at the inside of a river bend. Site is covered with broken concrete blocks and other debris. [2017 Site ID:RD0524U01RM45.07]

Front view of the site. Note the loosely placed concrete blocks at the site.

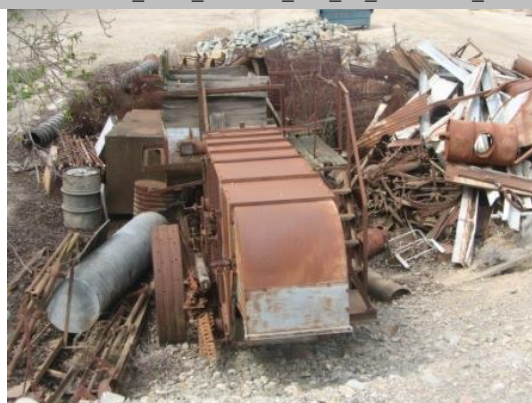
Photo 1 of 1 : FA_2018_RD0524_107_66_20180906_00115.jpg

LM Start	4.60	Rating **	M	Issue No.	66
LM End	4.60	Issue Type +	En	Location *	LS
Category	Earthen Levee			GPS Latitude/Longitude	
				Start	End
Item	Encroachments			37.891365 °	37.891365 °
				-121.328633 °	-121.328633 °
DWR ID	DWR_RD0524_01_s_2012_66				
Comment Code					
GA : Garbage					
Inspector Comment					
Old farm equipment at landside toe.

Garbage at landward toe next to ramp at LM 4.64

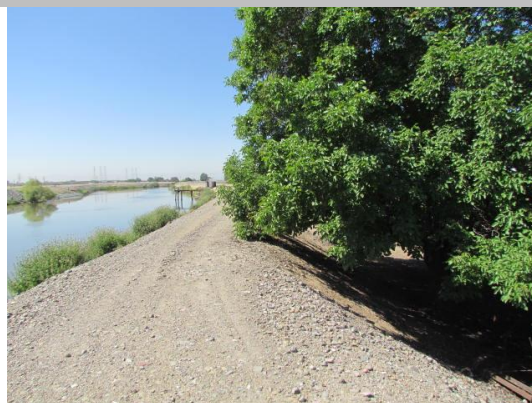
Photo 1 of 1 : FA_2018_RD0524_107_63_20180906_00114.jpg

LM Start	4.61	Rating **	U	Issue No.	63
LM End	4.61	Issue Type +	Ma	Location *	LS
Category	Earthen Levee			GPS Latitude/Longitude	
				Start	End
Item	Trim / Thin Trees			37.891285 °	37.891285 °
				-121.328728 °	-121.328728 °
DWR ID	DWR_RD0524_01_s_2012_63				
Comment Code					
T1 : Trim trees to at least five feet above ground level.					
Inspector Comment

Looking south at dense trees on landside slope.

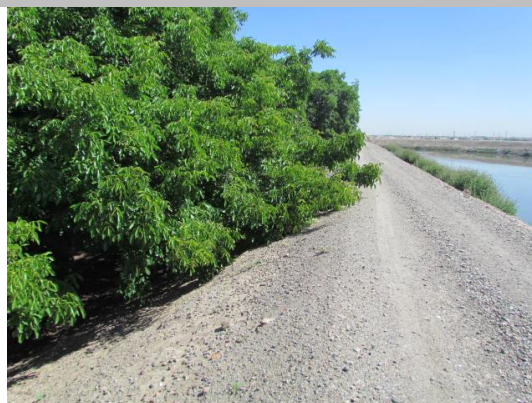
Photo 1 of 1 : FA_2018_RD0524_107_113_20180906_00178.jpg

LM Start	4.63	Rating **	M	Issue No.	113							
LM End	4.63	Issue Type +	Ma	Location *	LS							
Category	Earthen Levee		GPS Latitude/Longitude									
			Start	End								
Item	Trim / Thin Trees		37.890973°	37.890973°								
			-121.328970°	-121.328970°								
DWR ID	DWR_RD0524_01_s_2012_113											
Comment Code												
T1 : Trim trees to at least five feet above ground level.												
Inspector Comment

Looking north at dense trees on landside slope.

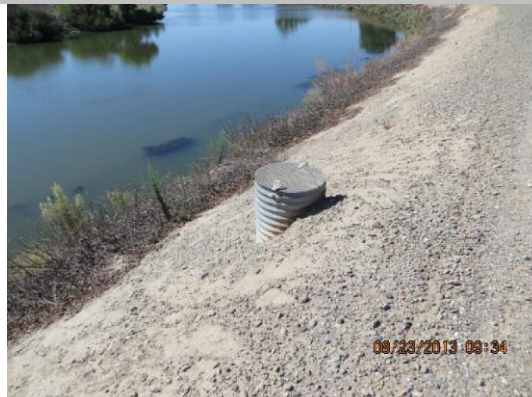
Photo 1 of 3 : UCIP_FA_2018_22728_38453.jpg

LM Start	4.89	Rating **	M	Issue No.	961	
LM End	4.89	Issue Type +	En	Location *		
Category	Supplemental			GPS Latitude/Longitude		
				Start		End
Item	DWR UCIP Field Study			37.887694 °		37.887694 °
				-121.331019 °		-121.331019 °
DWR ID	20628					
Comment Code						
Inspector Comment						
FS_ID:22728						
DS_ID:20628						
EP_NO: 3817						
Repair Type: Non-Urgent						
Crossing Status: Found						
UCIP Comments: Appears abandoned and if so should be done so properly.						
FIELD_STRUCT_DESC: *ABANDONED* 6-inch steel drainage pipe through the levee, 3 feet below the crown. Pump 120 feet off the landside (LS) toe. Siphon breaker in 24-inch corrugated metal riser unit on the waterside (WS) shoulder. (Permit No. 3817, 1961 - Ohm and Saunders). [Additional Reference(s): DWR Levee Log, 2004. USACE San Joaquin O&M Manual 7, April 1964, (HLM 4.95)].						
FS Date: 8/23/2013

Siphon breaker in 24-inch CMP riser on WS shoulder.

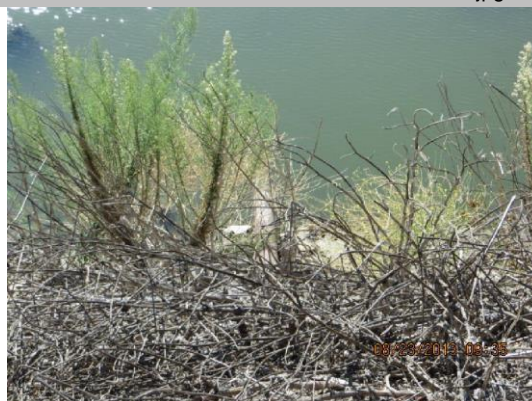
Photo 2 of 3 : UCIP_FA_2018_22728_38452.jpg

Pipe visible on WS toe.

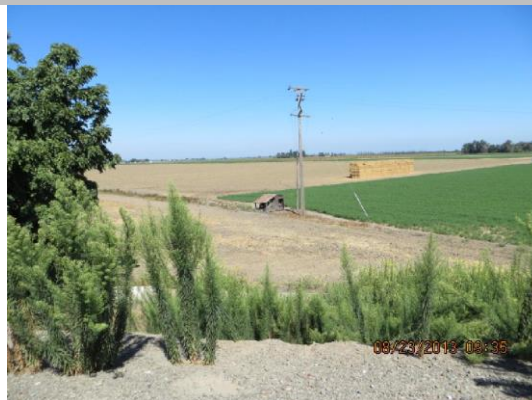
Photo 3 of 3 : UCIP_FA_2018_22728_38451.jpg

Pump in pumphouse 120-feet off LS toe.

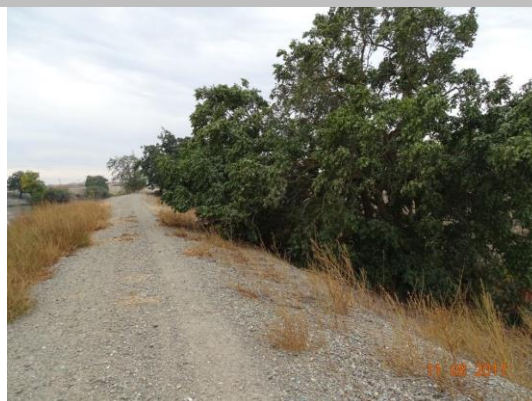
Photo 1 of 1 : FA_2018_RD0524_107_266_20180906_00355.jpg

LM Start	5.12	Rating **	U	Issue No.	266
LM End	5.16	Issue Type +	Ma	Location *	LS
Category	Earthen Levee			GPS Latitude/Longitude	
				Start	End
Item	Trim / Thin Trees			37.884608 °	37.884023 °
				-121.332153 °	-121.332100 °
DWR ID	DWR_RD0524_01_f_2017_266				
Comment Code					
T1 : Trim trees to at least five feet above ground level.					
Inspector Comment

Looking south at the landside slope.

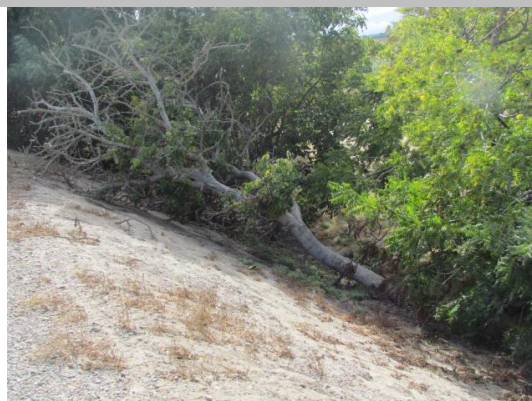
Photo 1 of 1 : FA_2018_RD0524_107_178_20180906_00234.jpg

LM Start	5.39	Rating **	M	Issue No.	178
LM End	5.39	Issue Type +	Ma	Location *	LS
Category	Earthen Levee			GPS Latitude/Longitude	
				Start	End
Item	Encroachments			37.880806 °	37.880806 °
				-121.332833 °	-121.332833 °
DWR ID	DWR_RD0524_01_f_2014_178				
Comment Code					
TR : Tree or limb					
Inspector Comment					
Downed tree on landside toe.

Looking south at downed tree on landward slope.

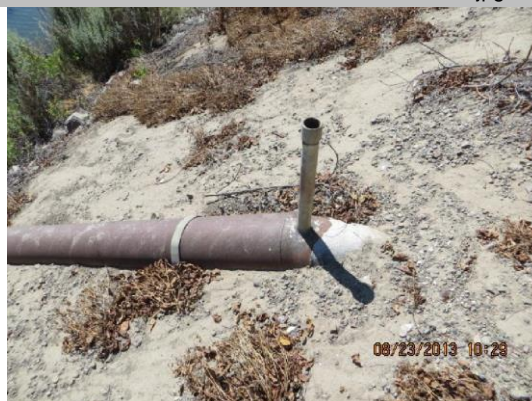
Photo 2 of 3 : UCIP_FA_2018_53358_30688.jpg

UCIP Comments: 10/2/2018 Same as last inspection. Holes present in pipe pose a potential threat to levee's internal integrity. Recommend video inspection (D. Sanoski - DWR UCIP). 11/16/2016 same as previous inspection hole in pipe is still present on WS near toe. This pipe does not appear to be in use. Need to contact owner to determine status of crossing. If the crossing is abandoned or still in use, owner will need to coordinate with the CVFPB to comply with Title 23 requirements. (O. Magana - DWR UCIP) 08/23/2013 flap gate damage and does not work at WS toe. Large hole in pipe at WS toe. Pipe appears abandoned and should be done so properly. (W. Wylie - DWR UCIP)

Vent on pipe on WS slope. Possible slurry standpipe that has not yet been used.

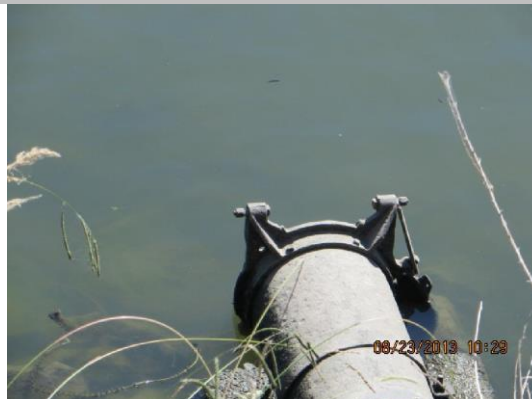
Photo 3 of 3 : UCIP_FA_2018_53358_30687.jpg

Broken flap gate at WS toe.

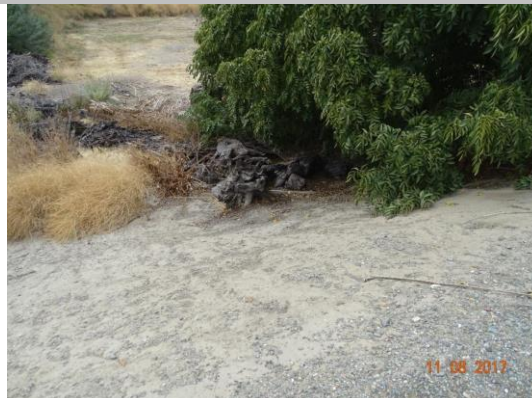
Photo 1 of 1 : FA_2018_RD0524_107_269_20180906_00357.jpg

LM Start	5.41	Rating **	M	Issue No.	269
LM End	5.41	Issue Type +	En	Location *	LS
Category	Earthen Levee			GPS Latitude/Longitude	
				Start	End
Item	Encroachments			37.880468 °	37.880468 °
				-121.332909 °	-121.332909 °
DWR ID	DWR_RD0524_01_f_2017_269				
Comment Code					
TR : Tree or limb					
Inspector Comment

Looking west at the landside slope.

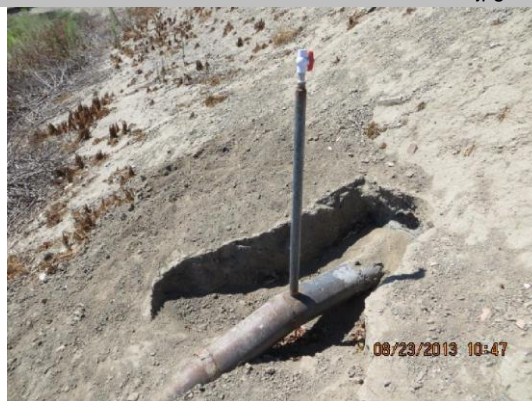
Photo 2 of 3 : UCIP_FA_2018_18348_30705.jpg

8-inch pipe sleeved through 10-inch pipe with vent on WS slope.

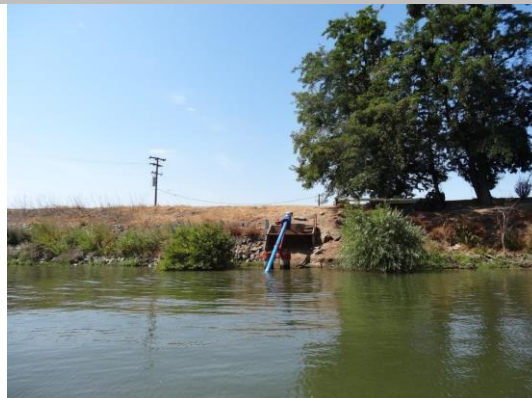
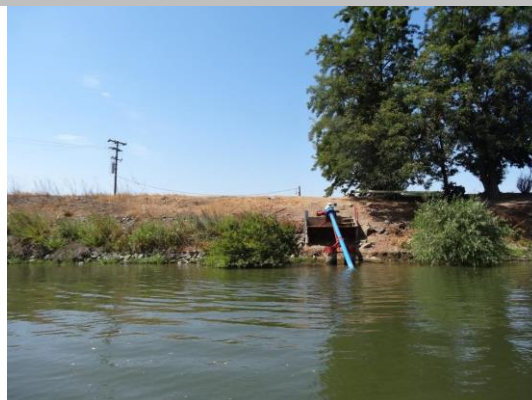
LM Start	5.53	Rating **	M	Issue No.	92
LM End	5.53	Issue Type +	Ma	Location *	WS
Category	Supplemental			GPS Latitude/Longitude	
				Start	End
Item	DWR Erosion Survey			37.878920 °	37.878920 °
				-121.332670 °	-121.332670 °
DWR ID	RD0524U01RM46.06				
Comment Code					
Inspector Comment					
09/13/2017: No significant change observed.					
07/25/2016: No significant change observed.					
06/24/2015: No significant change observed.					
06/19/2014: No significant change observed.					
08/13/2013: Larger trees are at the levee shoulder, and an irrigation pump station is next to the erosion site. [2017 Site ID:RD0524U01RM46.06]

Front view of the erosion.

Close view of the site.

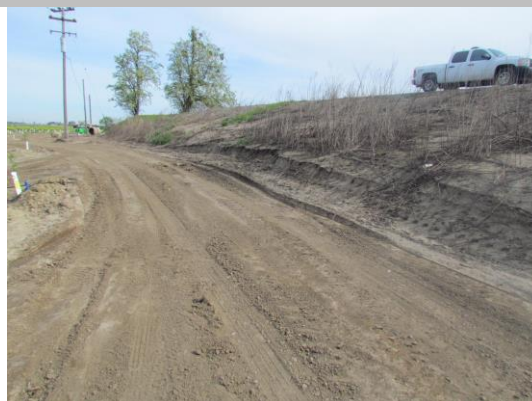
Photo 1 of 2 : FA_2018_RD0524_107_166_20180906_00216.jpg

LM Start	5.56	Rating **	U	Issue No.	166
LM End	5.56	Issue Type +	En	Location *	LS
Category	Earthen Levee			GPS Latitude/Longitude	
				Start	End
Item	Encroachments			37.878333 °	37.878333 °
				-121.332875 °	-121.332875 °
DWR ID	DWR_RD0524_01_s_2017_166				
Comment Code					
AT : Agricultural tilling					
Inspector Comment					
Damaged landside toe appears to be caused by farming activity.

Looking northeast at cut into landward toe.

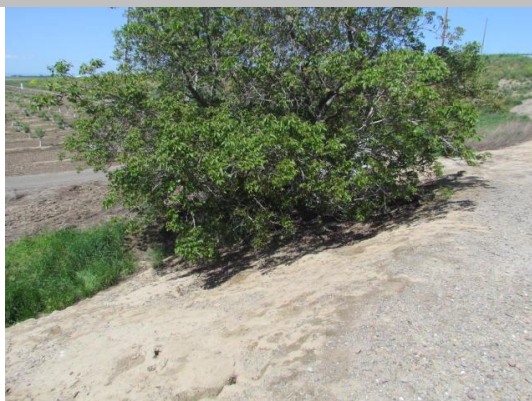
Photo 1 of 1 : FA_2018_RD0524_107_117_20180906_00181.jpg

LM Start	5.64	Rating **	M	Issue No.	117
LM End	5.64	Issue Type +	Ma	Location *	LS
Category	Earthen Levee			GPS Latitude/Longitude	
				Start	End
Item	Trim / Thin Trees			37.877272°	37.877272°
				-121.332400°	-121.332400°
DWR ID	DWR_RD0524_01_f_2013_117				
Comment Code					
T1 : Trim trees to at least five feet above ground level.					
Inspector Comment

Looking northwest at untrimmed tree on landward slope.
